port No. FHWA/RD-81/087

DETECTION OF FLAWS IN REINFORCING STEEL IN PRESTRESSED CONCRETE BRIDGE MEMBERS

April 1981
Final Report

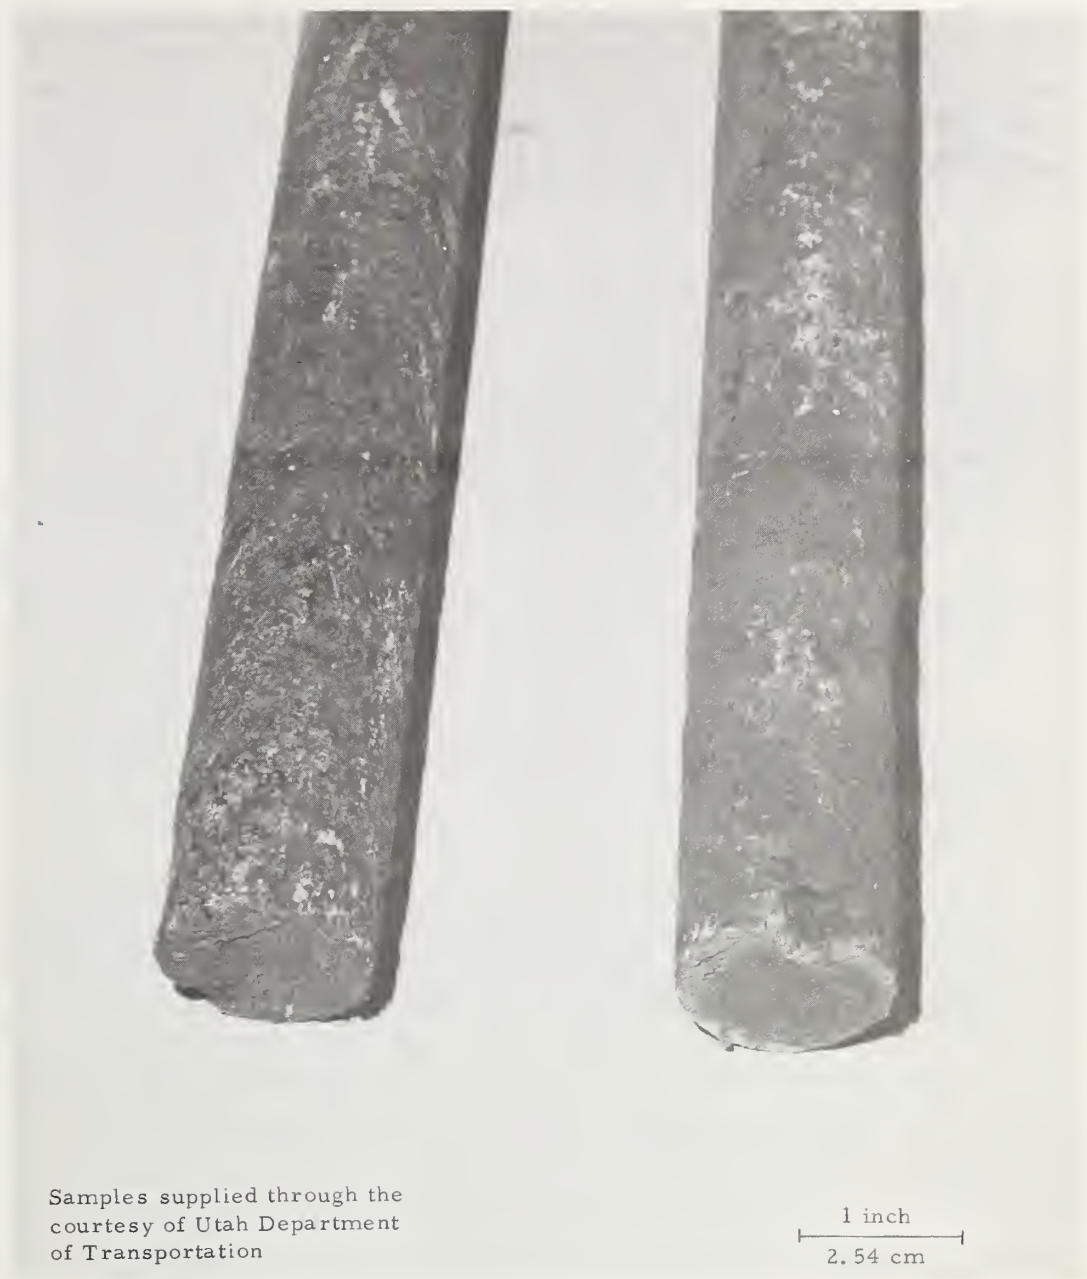
FIGURE 1. OVERALL VIEW OF TWO FRACTURES FROM SIXTH SOUTH VIADUCT STRUCTURE IN SALT LAKE CITY

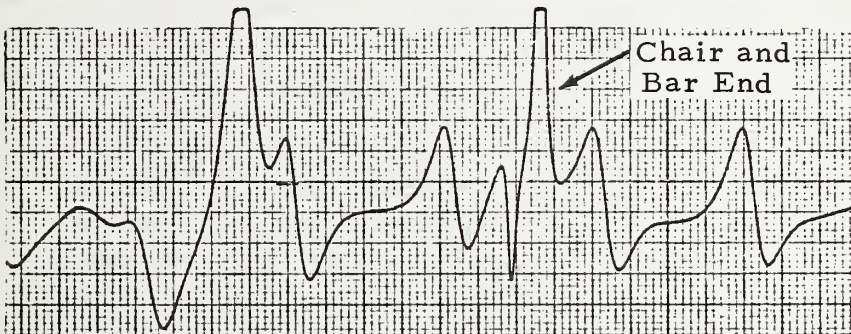
Laboratory Mockup, "L" StIRRups, Chair, and Bar End

Laboratory Mockup, "L" StIRRups, Chair, and Simulated Fracture

FIGURE 41. MAGNETIC RECORDS SHOWING CORRESPONDING CHARACTERISTICS BETWEEN SIGNATURES OBTAINED FROM THE FIELD AND THOSE FROM LABORATORY MOCKUPS

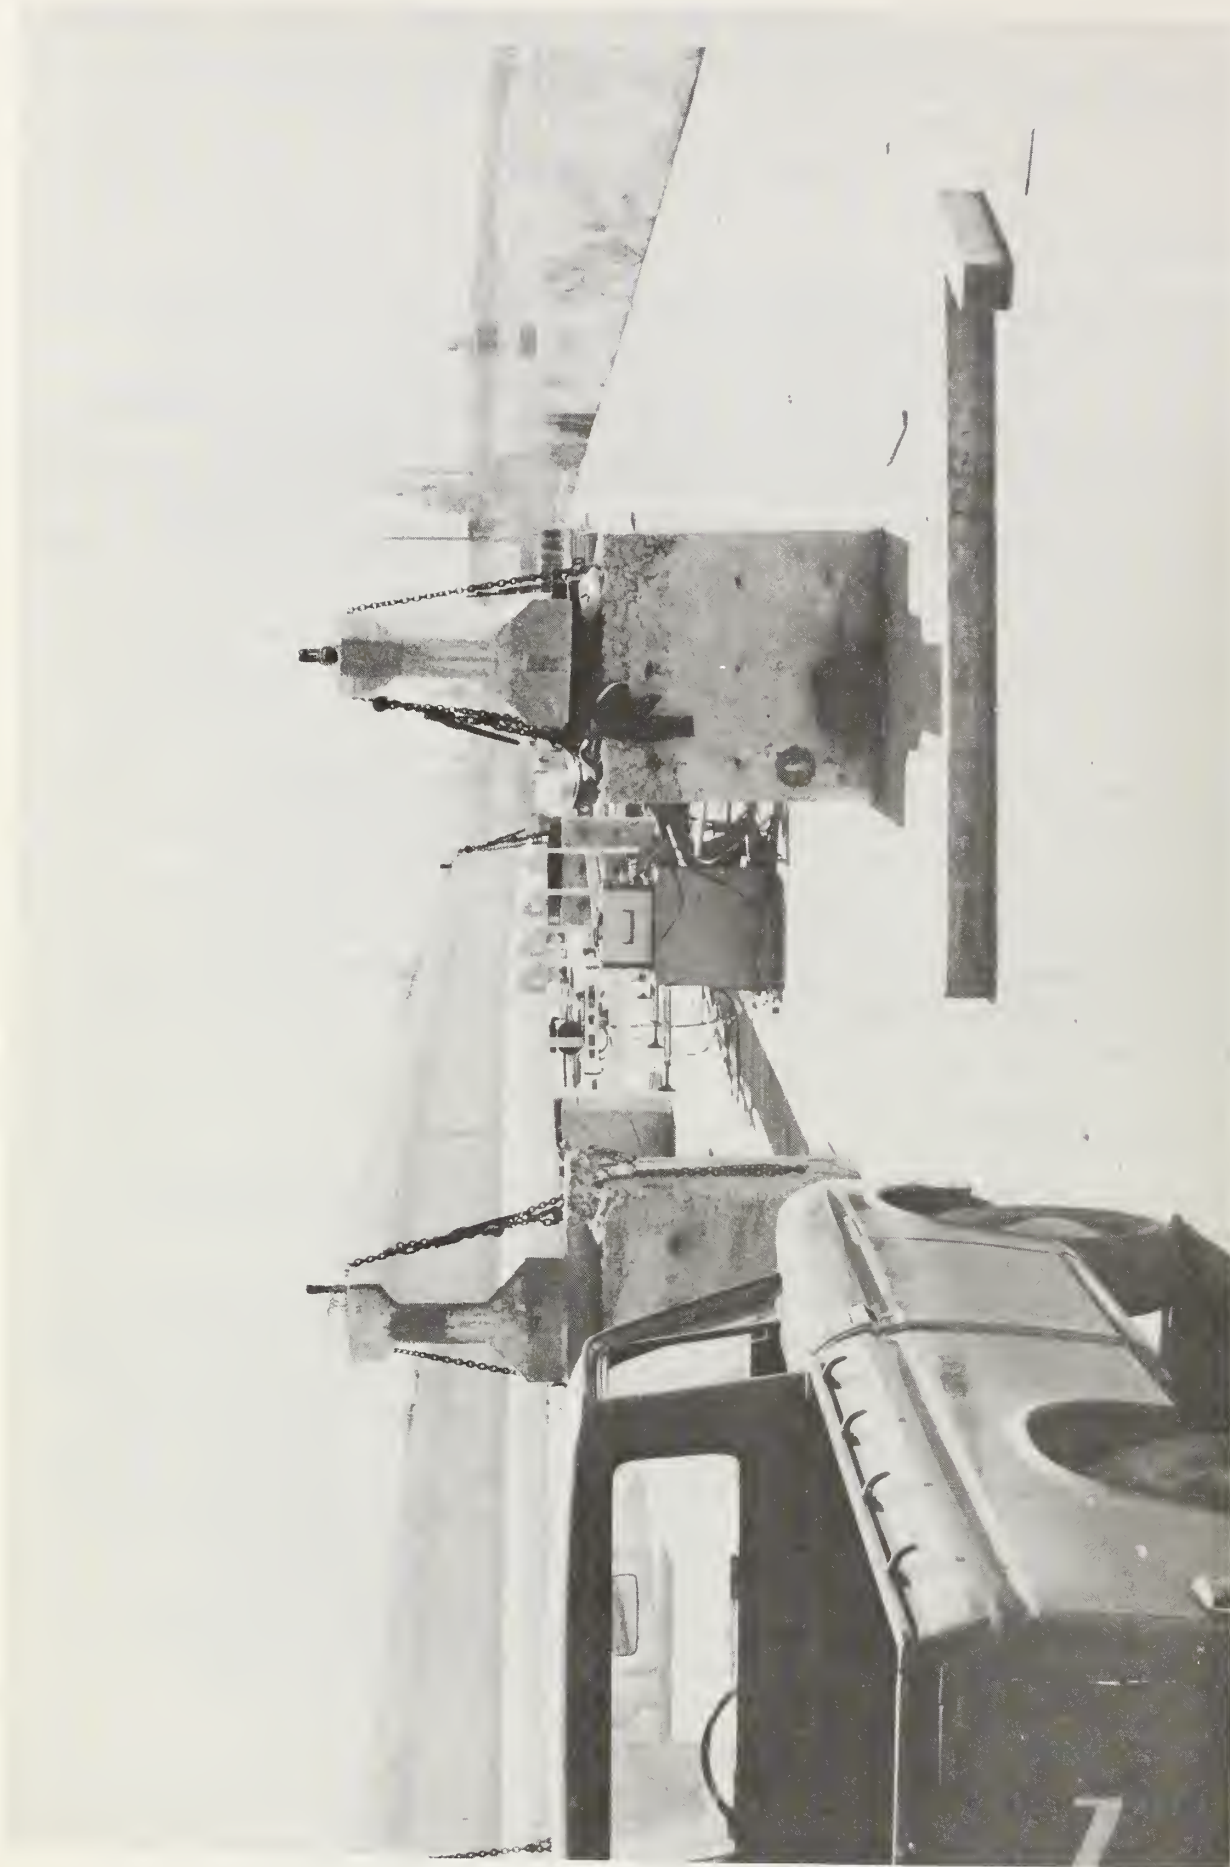
FIGURE IV-1. OVERALL VIEW OF FIELD SITE AT MANUFACTURED CONCRETE, INC. (formerly McDonough Brothers, Inc., San Antonio, Texas) SHOWING THREE TYPICAL 80-FOOT (24m) TYPE "C" GIRDERS SET UP

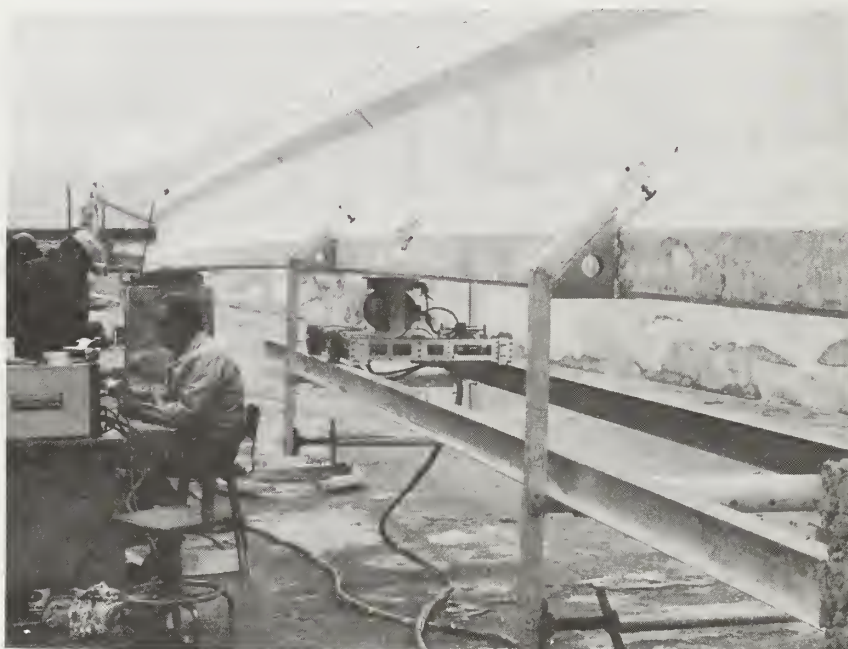
B. View of Inspection Setup on Reject Girder

FIGURE IV-3. VIEWS OF MAGNETIC INSPECTION EQUIPMENT INSTALLED ON GIRDERS AT MANUFACTURED CONCRETE, INC. (formerly McDonough Brothers, Inc., San Antonio, Texas)
